## Economic Analysis of an Alternative Fish Raceway System

Daniel Miller and Gerard D'Souza, Division of Resource Management, Davis College of Agriculture, Forestry & Consumer Sciences, West Virginia University, P.O. Box 6108 Morgantown, WV 26506-6108, [dmille31@wvu.edu](mailto:dmille31@wvu.edu); and Charles Conklin, Big Brown Fish Hatchery, P.O. Box 584 Effort, PA 18330

August 2008

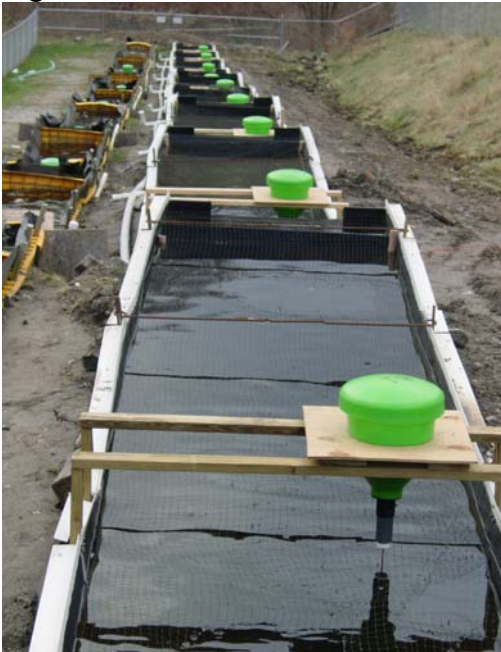
Figure 1 Plastic research tanks

Water quality was monitored in the plastic tanks using a YSI 600XLM sonde that recorded temperature, pH, oxygen and conductivity every hour. A YSI oxygen meter was used for temperature and oxygen readings from the concrete system. A certified analytical laboratory analyzed water samples from both sites for anions and cations in order to identify any parameters that were outside the accepted range for growing rainbow trout. A layout of the “U” shaped plastic tank system is shown in Figure 1 (below left). The concentrated solids in the settling zone are shown in Figure 2 (below right).

Five 30 foot sections of 60 inch diameter HDPE pipe were cut in half longitudinally to create 10 tanks each with a volume of 2000 gallons. The pipe has a ribbed exterior and a smooth interior providing a double hull to protect against leaks. End caps were heat welded on each end and each discharge side had a 36 inch wide weir notch on the end plate and a hole cut at the bottom to allow for the hydraulic pressure to push the solids into a 3 inch perforated pipe when a waste valve was opened for cleaning. Nine tanks were intended to be placed into the ground approximately 18-24 inches deep with a 3 foot drop between each tank. Improper installation by the contractor caused stability problems with the tanks that were set on the ground rather than in the ground.
